# Diagnosis and Mitigation of Chronic Water Ingress in Multi-Storey Residential Buildings

Anirudh Mustyala

**Abstract:** *This case study involves finding the source of leakage and seepage in a ceiling of a room in a penthouse located in posh Versova area of Mumbai, the top metropolitan city of Maharashtra state in India. Running water has been detected on one of the ceilings of a room on level 1 of the penthouse. This case study explores and studies different suspected sources of leakage and moisture and also studies each source in-depth to zero-in the source of water. The study also explores potential causes, including structural anomalies and concealed pipelines, and proposes comprehensive waterproofing and repair strategies to mitigate the problem. The findings emphasize the importance of proper maintenance and timely intervention to prevent long term structural and health hazards in residential buildings.*

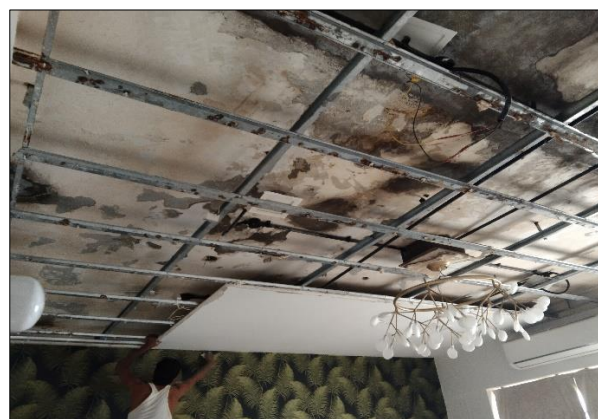
This case study explores the problem of seepage in level 1 of a three-story penthouse located on the 14th, 15th and 16th floors of high-rise building in Mumbai city in India. The problem surfaced when a gyroc ceiling lost its strength due to presence of moisture and water and fell down-a serious life and health hazard. The subject ceiling is depicted in figure... Upon inspection we could clearly see huge signs of water leaking from the slab. However, we were informed there is a room above this room, with no water connections. Our task now was to find out other sources of water inlets, resulting into this sever water leakage.

Figure 1: Condition of the Subject Ceiling on Level 1

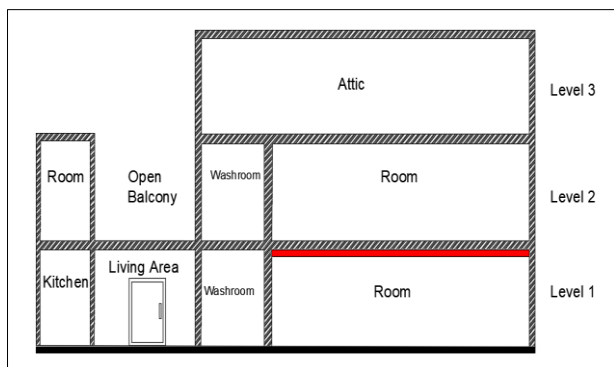
Figure 1: AutoCAD Elevation of the Penthouse

AutoCAD elevation is shown in Figure 1 of this case study. Leakage has been detected on the ceiling of a room on level 1 of the Penthouse. This ceiling has been marked in red in figure 1 for the sake of clarity.

We can clearly see that there are a number of sources connected to the leaking ceiling, that could be potential sources of leakage in the subject ceiling. The next section deals with each and every suspected source of leakage, and why it is earmarked as such.

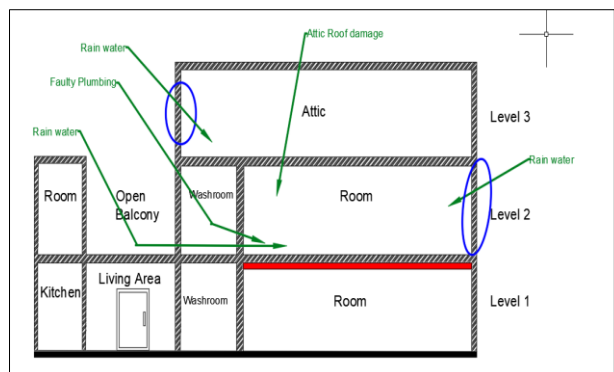
Figure 2: Marking of suspected Sources of Water

The following figure, i.e. figure no 2, depicts all the possible sources of leakage which could be a reason for seepage from the subject ceiling. In this section we shall discuss each reason one and one and why we reason out that these could be the cause of seepage in the subject ceiling.

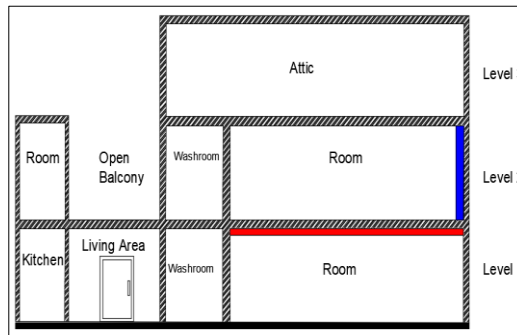
Figure 3: Window On Level 2

The first suspected leakage can happen from the window above the subject room. There is a room above the subject room on Level 2 and on inspection of the room, we found that there are no visible water connections or known pipelines under the floor which can become a probable source of leakage.

However, there is a huge French window in the room as shown in Figure 3, which does not have proper structured or a temporary awning outside the wall, meant to prevent rain water to enter the room during monsoons.

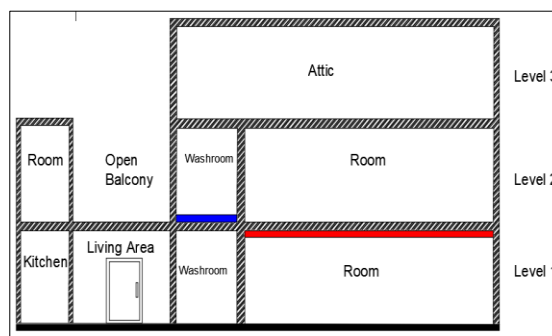
Figure 4: Washroom Above the Subject Ceiling

The second source of seepage in the subject room can be the washroom attached to the room above the subject room. There could be two possible sources of water leakage from this washroom. The first could be faulty underfloor plumbing, which could be releasing water to the surrounding areas, and this water could be leaking from the slab to the room below.

The second source could be faulty or absent waterproofing membrane in the washroom. We suspect that waterproofing has not been done in the sunk area properly due to which ant water or moisture must be leaking into the slab and reaching the ceiling of the subject room.

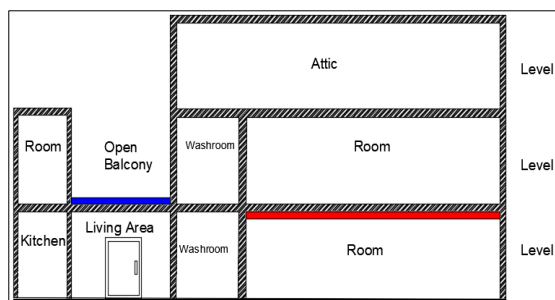
Figure 5: Adjoining Balcony on Level 2

The next source of water could be the open balcony adjoining the washroom on level 2. This balcony has old flooring, numerous tiles and broken and grouting is missing.

The skirting is also missing at many places and thus our team thinks that there could be many pathways through which the water could be seeping into the slab underneath, making its way to the ceiling of the subject room.

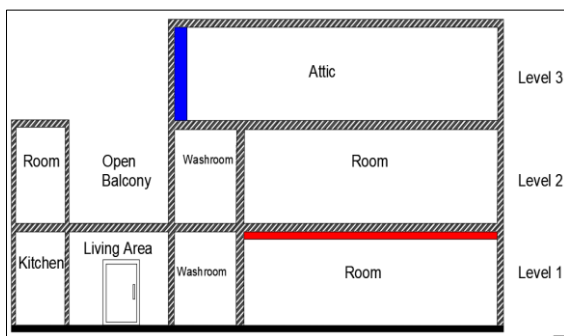
Figure 6: The Attic Window

The next source of leakage can be seen expected on the top level. There is a large round window with an old wooden frame. This wooden frame is in direct contact with heavy rainfall as well as high temperature direct sunlight, due to which the frame of the window is severely damaged and rotten. Moreover, the glass pane of the window has a missing part, which, according to the owner, has been sent for repair and by virtue of huge tasks of maintenance, the owner has completely forgotten about return delivery and installation. The figure below is a diagrammatic representation of the area from where water could be coming into the attic and seeping into its flooring. The water could thereafter, be seeping into the wall of the room on level 2, from where it could be seeping into the slab between the rooms at level 1 and level 2.

Next, there is a huge round window in this room which has a wooden frame. This wooden frame is completely spoiled due to presence of a lot of rain due to which there are large holes in this frame have been noticed. Moreover, a huge glass part of the pane is seen missing, which the owner says, broke a shattered a long time ago and has been sent for repair the previous year. This clearly means that this monsoon, there has been a large open window which has allowed all the rain water to enter the attic. We removed the whole wooden frame and replaced it with airtight, waterproof and insulated aluminium frame with acrylic pane, so as to make it stronger to bare the strong winds and rains.

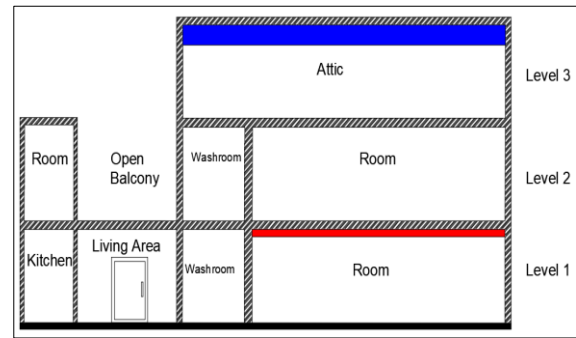
Figure 7: The Attic Slanting Roof

The attic has a slanting roof. This roof is very old and is made of slabs of terracotta. This terracotta, due to direct the engagement with a highest temperature from sunlight and also heavy rains in the monsoon could have developed cracks or could have broken due to which water maybe seeping into the shed flooring, from where it is going down to the level under it and seeping through the slab and going into level 1 so this is also a highly suspected source of leakage which has to be studied accordingly.

Another source of leakage that we understand is the slanting roof of the attic. As mentioned before, the slanting roof is made of material which has high water absorbing capacity, maybe slate or terracotta. The Slate slabs are also very old and marks of cracks the marks of damage and due to wear and tear of high temperatures from sunlight and heavy rainfall can be seen. This shed is one of the major sources of leakage in the whole penthouse. Therefore, we brought a team of masonry and re-built the whole attic.

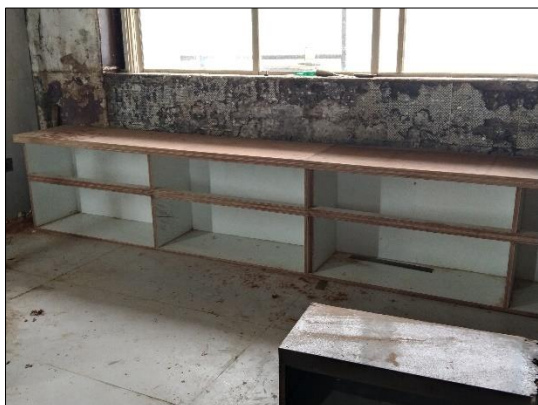
inspection we found out that the furniture under the window had presence of water remains and high amount of moisture in it therefore we concluded that the window is a source of water entering into the room. So we removed the permanent cabinet structure to inspect the back side of the furniture in such a way that if its found to be in good condition, it can be put back and reused as earlier. Upon inspection it was found that the back of the furniture was completely spoiled due to the entry of water from the window.

The photo below depicts severe water input from the window and it has damaged the wall structurally.

**Figure 3:** Condition of the Window Wall on Level 2

This majorly happened due to the fact that the window had no protruding covering or awning above it to restrict entry of rain entering the room. Figure 3 and Figure 4 depict permanent and temporary awnings respectively for usually installed at residential as well as commercial premises exposed to heavy rainfall in the city of Mumbai.

Since the water is entering from the window directly behind the furniture, it does not get a chance to dry or to be cleaned, so the water has been seeping into the room and there is huge probability that this water seeps into the slab between level 1 and level 2 and has been a primary reason of leakage in the room below.

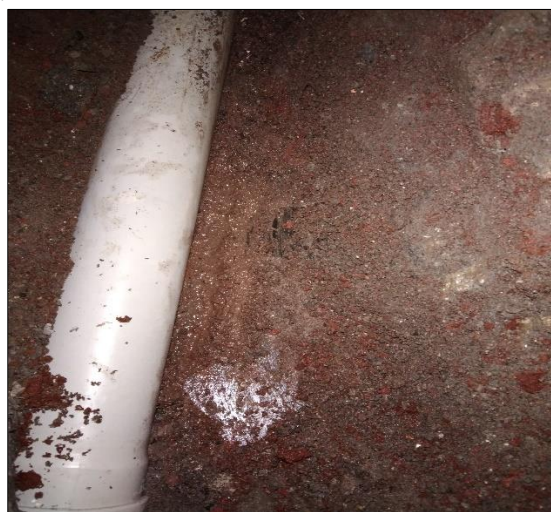
The second suspected source of water of leakage that is to be understood or research is the faulty plumbing in the bathroom at level 2. Once the washroom was unearthed, we found out that plumbing is faulty, has been done in a hurry and completely unprofessional. Thereafter we also saw that there is a lot of collection of water under these pipes, which means when the bathroom is being used regularly, the water is seeping from the pipes and collecting under the pipes on the slab.

**Figure 5:** Water near Underground Pipes

There is a high probability of this water to seep into the slab and thus entering the ceiling of the subject room.

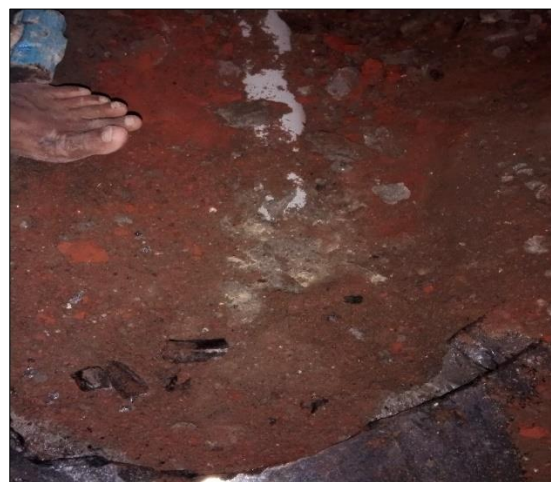
Other than the above, we also found that the waterproof membrane of the sunk slab has not been done properly. When we dug out the slab, we found loose sand and silt, the base made of bricks and cracks in the plaster as can be seen in the photo below.

**Figure 5:** Bricks used instead of Waterproof membrane

Bricks have high moisture absorbing capability and the absence of waterproof membrane has resulted into high amount of running water into the slab between Level 1 and Level 2.
