Stability Analysis and Optimization Design of Composite Slopes in Open-Pit Mines

Abstract: *Mineral resources play a crucial role in modern construction, and open-pit mining is the primary method for resource extraction. Ensuring slope stability is vital for the normal operation of open-pit mining. This study focuses on an open-pit coal mine in Xilin Gol League, Inner Mongolia, China. Through comprehensive methods such as geological data collection and analysis, field investigation, and UAV mapping, the Slope/W module in GeoStudio software was employed, and the Bishop limit equilibrium method was used to perform a stability analysis on two cross-sections of the composite slope between the mining pit's East Slope and the external dumping site. The results showed that the safety factors for these two sections of the composite slope do not meet the required reserve safety factor. After applying a toe-weighting optimization design, a subsequent stability analysis was conducted, ensuring the stability requirements were met. The main factors affecting the stability of the composite slope were analyzed, including the geotechnical properties, slope rock mass structure, the design distance

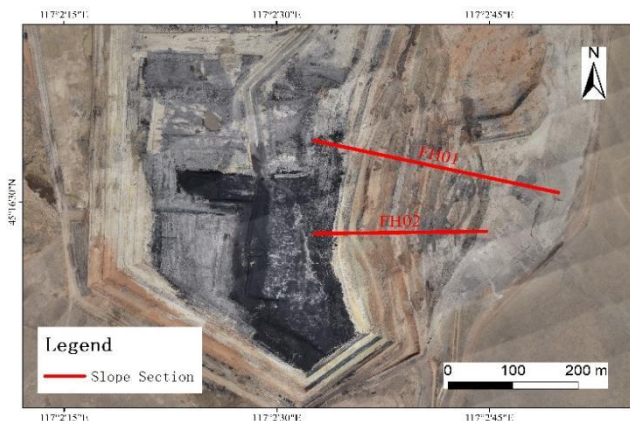
Figure 3: Selection of Slope Profile Location

Aerial photogrammetry using drones was conducted for the mining area, and modeling was completed to obtain remote sensing imagery and elevation data. Based on this, two profiles of the East Slope of the mining area and the external spoil dumping site composite slope were selected for stability analysis, as shown in Figure 3. Considering that the East Slope of the mining area is influenced by the load from the upper spoil dumping site, with a service life of less than 20 years, and the slope is relatively prone to instability due to its dip direction, the safety factor is determined to be 1.2, in accordance with relevant industry standards. Based on the borehole tests conducted by the mining company, and the empirical reduction of the physical and mechanical properties of the various strata, combined with the regional engineering geological conditions, the physical and mechanical properties of the rock mass were determined, as shown in Table 1.

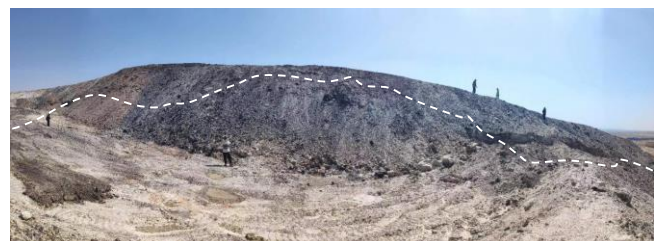
A detailed field investigation was conducted on the composite slope of the East Slope of the Mining Area and the External Dumping Site, revealing deformation traces. A north-south trending crack was visible in the upper part of the composite slope, extending for a linear distance of up to 200 meters. The crack is arcuate in shape (as shown in Figures 12 and 13), with extensions on both sides forming lower steps. The total estimated length of the crack is approximately 400 meters. A steep scarp is visible at the rear of the crack, with a dip direction of 91° and a dip angle of 80° . Vertical striations are observed on the crack surface, with a length of 85 cm. The most dangerous sliding surface in the stability analysis of the composite slope shows that the shear entry point is located on the external dumping site, which is consistent with the distribution of the rear crack observed during the field investigation.

Figure 12: Panoramic View of the Back Edge Fracture of the Composite Slope

Figure 13: Close-up View of the Back Edge Fracture of the Composite Slope

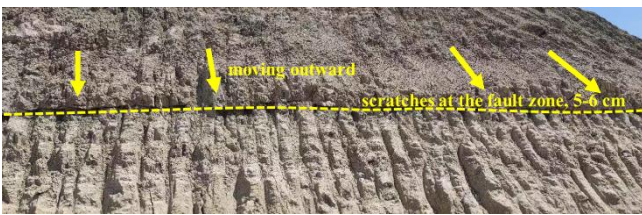
Figure 14: Displacement at the Front Edge of the Composite Slope

At approximately 910 meters elevation on the composite slope of the East Slope of the mining area and the external waste dump, the original rock layers have undergone displacement along a weak plane, primarily consisting of sandstone. After excavation of the original rock, the slope layers are observed to displace outward from north to south, with the maximum displacement reaching 5-6 cm, as shown in Figure 13. The stability analysis of the composite slope indicates that the most critical sliding surface has its shear entry point between 900 and 930 meters elevation on the East Slope of the mining area, which aligns with the distribution of front-edge fractures observed during the field investigation.
