# Research on Spatial Elements of Barrier-Free Environment Construction in Urban Livable Streets: A Case Study of Pingguo Yuan Street in Shijingshan District

This study starts from the space where people live for a long time, takes the emerging urban area of Pingguo Yuan Street in Shijingshan District as the research location, focuses on the spatial environment elements of high-quality travel in livable streets, and conducts optimization research on the spatial elements of barrier-free environment construction in livable streets for various groups of people with disabilities. By using spatial perception equipment and field research and interviews, this study collects data, analyzes and summarizes the design problems and potential risks of barrier-free environment construction in spatial elements, and aims to propose targeted optimization strategies, providing effective references for the construction of barrier-free environments in China and creating a high-quality living environment for all members of society.

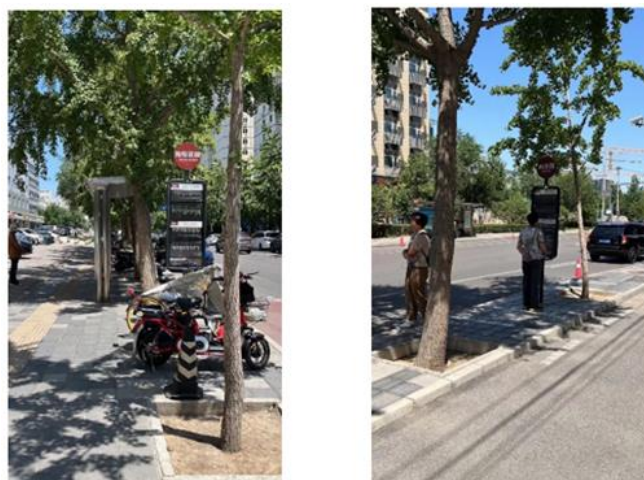
**Figure 7:** Haite Garden (left) and West Jing Road (right) bus stops

As shown in Figure 7, at the Haite Garden bus station, the tactile paving passes through the bus stop but does not have

special alerts for the visually impaired, and its location at the back of the bus station waiting area is unreasonable. The tactile paving is not connected to the waiting area. The Xijing Road bus station lacks tactile paving, and the bus station is not connected to the pedestrian pathway, making it impossible to establish a smooth circulation path for the visually impaired.

This study finds that there is a lack of accessible alert functions at points where road conditions change, at corners, and at key nodes leading to major buildings along Xijing Road. To address this issue, the following optimization strategies are

proposed: Firstly, enhance the identifiability of nodes. It is suggested to differentiate the paving materials at tactile path nodes to distinguish between different functional areas; adjust the colors of accessible facilities such as tactile paths and ramps at key nodes, for example, changing the traditional yellow to red, to enhance the visual cues for individuals with visual impairments. At the same time, optimize the tactile sensation wave level of the tactile path to improve recognizability. Secondly, add visual prompt lights and dynamic indicators. Install visual prompt lights and dynamic indicators around key street nodes and public facilities, with special attention to the inconsistency of accessible facilities at bus stations on Pingguoyuan Street. Pay particular attention to areas with inconsistent accessible facilities, such as bus stations on Pingguoyuan Street. Thirdly, retrofit bus stations for accessibility: Firstly, popularize electronic station signs that provide real-time voice announcements of vehicle information to serve individuals with hearing impairments; secondly, set up wheelchair paths with ramps and anti-slip edges to ensure the safety and comfort of wheelchair passengers; thirdly, optimize waiting areas, divide queuing areas by route, and set up handrails with Braille and vehicle information for the identification and use by individuals with hearing and visual impairments; fourthly, install touch screen information query terminals, equipped with touch screens, to provide real-time traffic information and route guidance, supplementing the lack of audio signals, and better serving individuals with various disabilities.

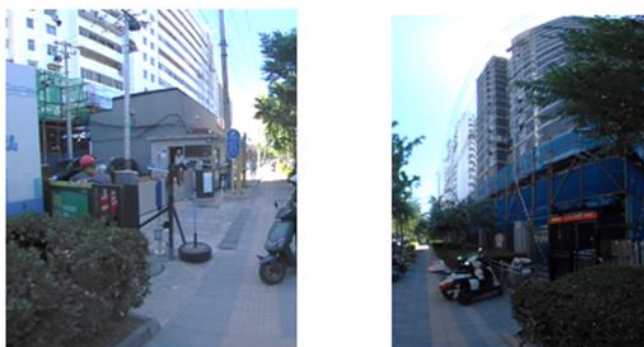
**Figure 8:** (left) Gate 1 North of the West District in Haite Garden Residential Area; (right) Gate 2 North of the West District in Haite Garden Residential Area

As shown in Figure 8, the entrance and exit of the western district of Haite Garden residential area lack special alert tactile paving. Walking along a straight thoroughfare, like Xijing Road, the absence of alert tactile paving leads to a high degree of regional similarity, making it difficult for individuals with disabilities to locate specific destinations.

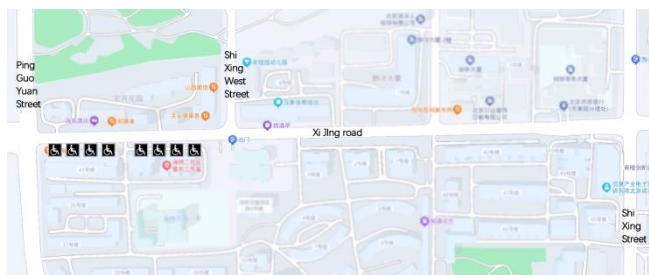
**Figure 9:** Distribution map of barrier-free facilities

As shown in Figure 9, accessible facilities are clustered at the entrance of the community service center and the police station, located on the western side of the road to the south of Xijing Road. This is in close proximity to the North Gate 1 and 2 of the western district of Haite Community. These facilities are also situated along the main circulation route, which enables individuals with disabilities to access them quickly and conveniently for comprehensive consultation and assistance services. This facilitates the rapid resolution of real-life issues they may face, thereby enhancing their quality of life. However, it is apparent that the distribution of accessible facilities within the area is too concentrated, and the range of accessible facilities is limited, with the absence of essential public services such as accessible restrooms. Consequently, the overall implementation of accessibility in the area is still inadequate.

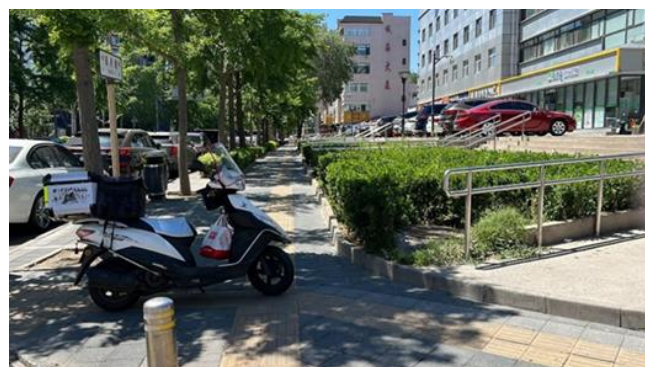
**Figure 10:** Overview of the Space on the North Side of Xijing Road

Regarding the vertical spatial scale, the majority of shops situated on the northern side of Xijing Road exhibit a discrepancy in height in relation to the sidewalk where tactile path nodes are positioned. As shown in Figure 10 and 11, The sidewalk is connected to the shops by stairs and there is no stone ramp or barrier-free ramp. The only ramp on the road has too steep an angle, so making it inaccessible for people with physical disabilities . It directly cuts off the possibility of people with physical disabilities wishing to engage in commercial activities on the north side of Xijing Road, making the road only a simple passing passageway for such people with physical disabilities, and does not promote economic development and enrich the life and entertainment of special groups. Simultaneously, the tactile path nodes on the northern side are also encroached upon by both motorized and non-motorized vehicles, indicating a deficiency in parking space in the area, which consequently leads to a reduction in barrier-free space.

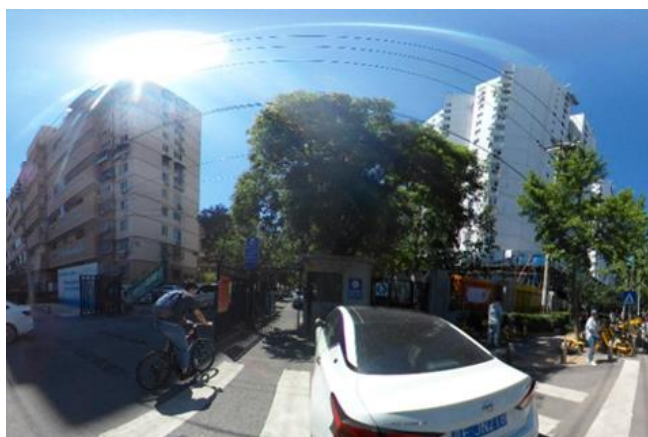
**Figure 12:** The North Gate of the West District in Hite Garden Residential Area

As shown in Figure 12, the pedestrian entrance and exit positions are not obvious and lack accessible signage. The pedestrian pathways at the entrances and exits of the residential area are relatively narrow and lack accessible facilities such as handrails. During peak morning and evening times, this can lead to congestion, which is not conducive to the smooth comings and goings of residents living their daily lives.

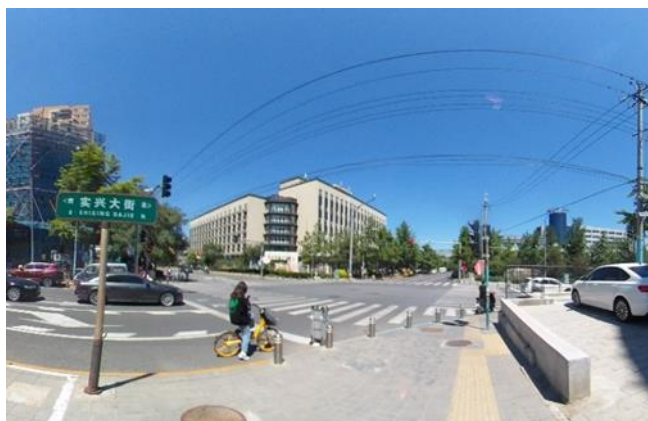
**Figure 13:** Intersection of Xijing Road and Shixing Street

Similarly, at crossroads, which are key locations for path selection, traffic lights, road signs, and volunteer guides provide vital route choice information for individuals with disabilities. As shown in Figure 13, this section of the road is equipped with complete signage and pedestrian crossing facilities that include voice prompts and audible signals, effectively ensuring barrier-free passage for the visually impaired and safeguarding the travel safety of special groups as they navigate intersections.

In response to the insufficient traffic light prompt function at the intersection of Pingguoyuan Street, this study suggests adding a voice broadcast function and flashing indicator lights to the traffic light system at major intersections to alert individuals with special needs to changes in traffic signals. The system can prompt the remaining time of the traffic lights based on sound frequency and regularly broadcast the current status of the traffic lights to ensure the safety of individuals with visual impairments crossing the road. For individuals with hearing impairments, visual prompt lights can be set up near the traffic lights to compensate for the lack of audio reminders.

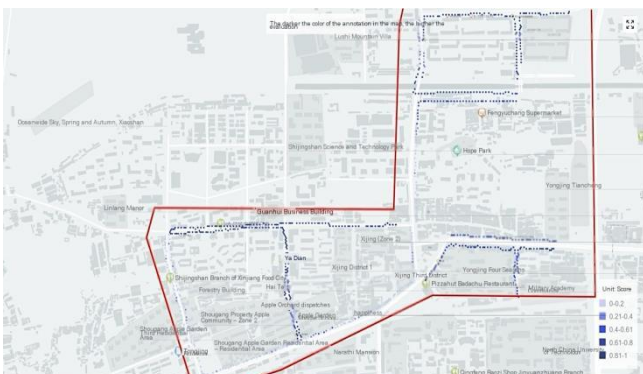
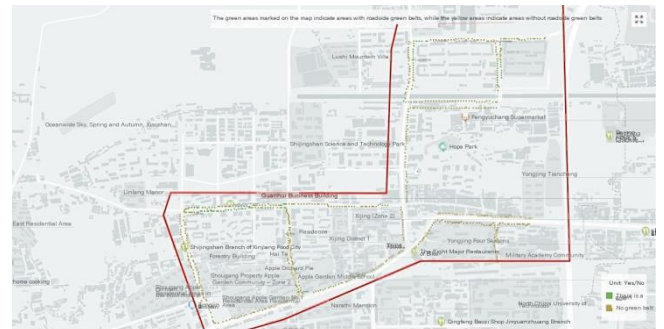
As shown in Figures 14-19, Xijing Road has excellent road smoothness and architectural style, but a poor degree of road openness, with relatively narrow spaces and a serious street odor problem. The road's sanitation is generally average; although the colors in the image are dark, they mostly range between 0.61-0.8, which is not considered excellent. Additionally, the distribution of green spaces in the area is uneven. Overall, the Xijing Road area has a poor barrier-free environment. It requires further management and rectification

of sanitation issues, as well as reasonable planning for the distribution of green spaces, to widen the field of view and ensure an open traffic space in the area.
