# Diagnosis and Mitigation of Chronic Water Ingress in Multi-Storey Residential Buildings

Anirudh Mustyala

**Abstract:** *This case study involves finding the source of leakage and seepage in a ceiling of a room in a penthouse located in posh Versova area of Mumbai, the top metropolitan city of Maharashtra state in India. Running water has been detected on one of the ceilings of a room on level 1 of the penthouse. This case study explores and studies different suspected sources of leakage and moisture and also studies each source in-depth to zero-in the source of water. The study also explores potential causes, including structural anomalies and concealed pipelines, and proposes comprehensive waterproofing and repair strategies to mitigate the problem. The findings emphasize the importance of proper maintenance and timely intervention to prevent long term structural and health hazards in residential buildings.*

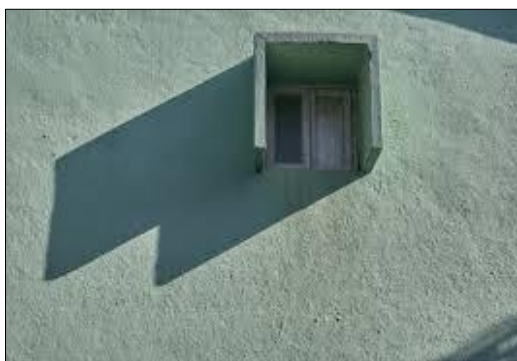
**Figure 3:** Permanent Window Covering

This majorly happened due to the fact that the window had no protruding covering or awning above it to restrict entry of rain entering the room. Figure 3 and Figure 4 depict permanent and temporary awnings respectively for usually installed at residential as well as commercial premises exposed to heavy rainfall in the city of Mumbai.
